# MP-1™ Polyimide for Medical Devices: 1. Pre Clinical Studies

Peter James Burn, Alisa Buchman, Simha Sibony, Amir Oron. MP-1™ Polyimide for Medical Devices: 1. Pre Clinical Studies. *American Journal of Biomedical and Life Sciences*. Vol. 7, No. 3, 2019, pp. 42-51. doi: 10.11648/j.ajbls.20190703.11

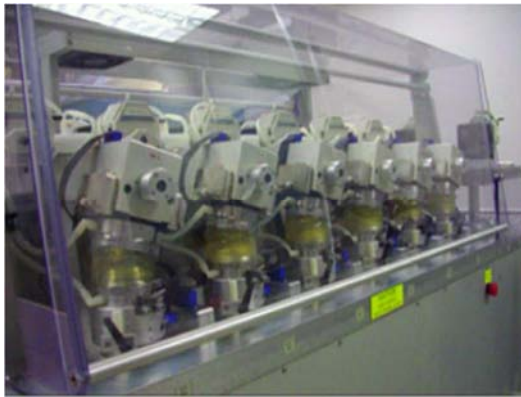
Figure 2. Hip simulator testing

The hip joint simulator performs 2x3 simultaneous tests (and two soaked controls) Figure 2. The specimens are oriented in an anatomically correct position; the resulting hip joint force was applied on the liner via the cup. Consequently, the direction of the force vector was constant relative to the cup and moved relative to the head. All three in-vivo angular displacements were simulated: Flexion / extension, abduction / adduction and internal / external rotation. The specimens were assembled under laminar flow conditions and sealed by capsulated single test chambers to exclude contamination. The temperature of the test fluid as well as the fluid level was controlled throughout the testing. The wear of the components was determined gravimetrically and calculated volumetrically.

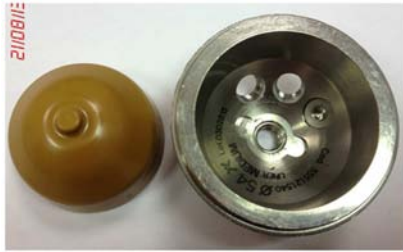
Figure 3. Cup and liner for testing.

23 liners were produced, according to CNC drawings, by compression molding of MP-1™ powder to blocks and machining the blocks to final liner shape (Figure 3). Every design of total hip arthroplasty system has usually three sizes; Small, Medium and Large (Table 1).

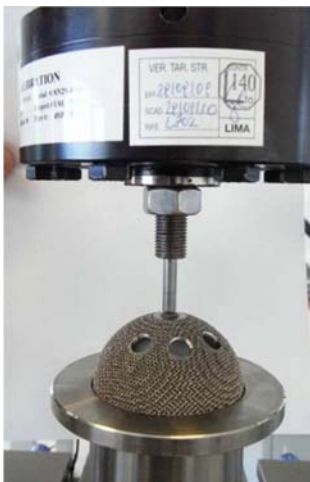
Figure 4. Push-out test.

Figure 5. Push-out test.

Modular Acetabular Device in push out test. Push Out Test six MP-1™ liners (MMATECH) were assembled into Delta TT shells featuring an 18-degree tapered internal geometry. Liners are pressed into the cup by means of a ceramic head at 2000±50 N maximum load (according to Ceramtec procedure). The whole system of cup and liner are subsequently put on a metallic ring which fully supports the cup but not the liner (Figures 4, 5).

The liner is pushed-out pressing on the polar protrusion with a 6 mm metallic plunge. The applied disassembly load is recorded by means of the load cell.

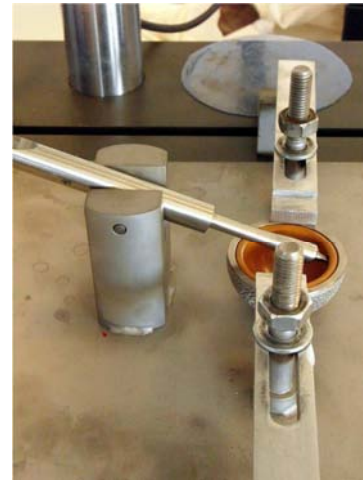
Figure 6. Lever-out test.

Figure 7. Lever-out test.

Lever out test is performed by disarticulating liner from cup by means of a lever arm (Figures 6, 7), lever is joined to MP-1™ liner by a hole in 5 mm diameter. The liner is pressed into the cup in with a force 2000±50 N.

The parameter considered to evaluate stability is the bending moment calculated by multiplication of applied force and the lever arm for the cosine of the inclination angle ( $\alpha$ ).

Force is applied till insert-cup disassembly. The lever bar is loaded at a rate of 5mm/ min. at the external side at 58,5 mm (b) from the fulcrum (Figure 6). The length of the lever arm from the fulcrum to its insertion point into the liner is 86,0 mm (a). The inclination angle ( $\alpha$ ) 25°. A force-displacement curve is recorded. The maximum lever out torque, (calculated by the maximum force multiplied by the lever arm length(b)) is presented as a further measure of the locking mechanism strength.

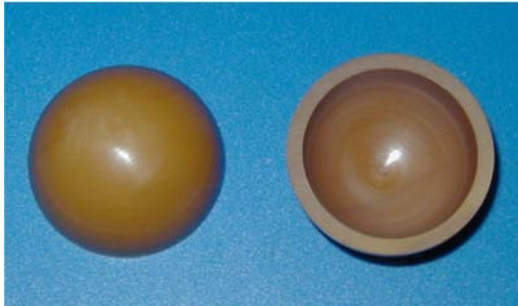
Figure 9. Test samples made of MP-1™ for impact test.

Six (6) MP-1™ samples were tested. Each sample was machined into hemispheres with a 38mm outer diameter and 2 mm thick (Figure 9). The parts were immersed in bovine serum, diluted 25% with buffer solution, to mimic the part's environment and friction conditions in the body.

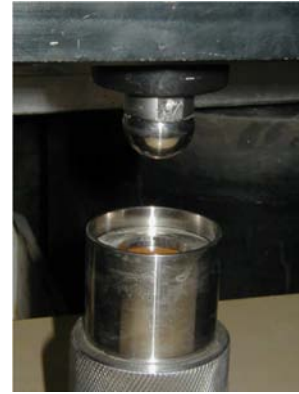
Figure 10. Impact test machine.

The Technion (ITT) developed the Impact Loading Machine. The machine has one air piston with 125 mm

internal diameter, and a pressure gauge for indication of the loading value.

The parts were placed in the concave station of the loading machine with the apex of the shell oriented downward (Figure 10). The Bovine Serum was poured into the test article such that the serum reached the top mark on the station's metal cup.

A pneumatically driven mechanism pressed a metal head against the test article in a vertical axis. The diameter of the metal head was 1 mm smaller than the internal diameter of the test article, causing a 0.5 mm clearance, which represents a typical clinical clearance scenario.

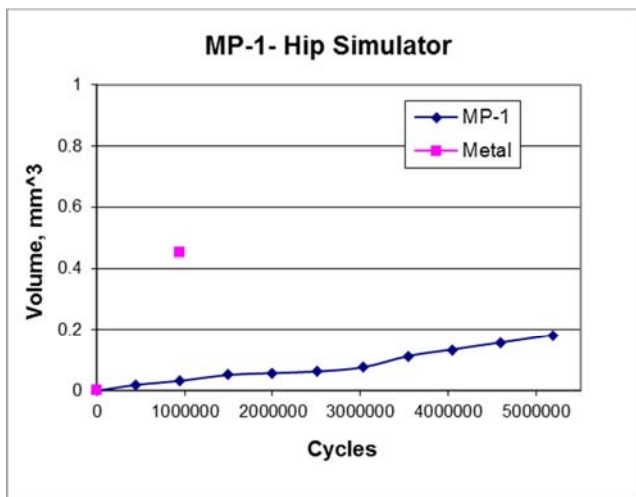
Figure 12. Hip simulator results of MP-1™ vs. Ceramic and metal vs. metal.

Figure 13 shows the volumetric results for the MP-1™ wear test of the hip simulator. These results resemble the wear after 5M cycles.

Under these conditions, the MP-1™ exhibited an order of magnitude less wear than the control.

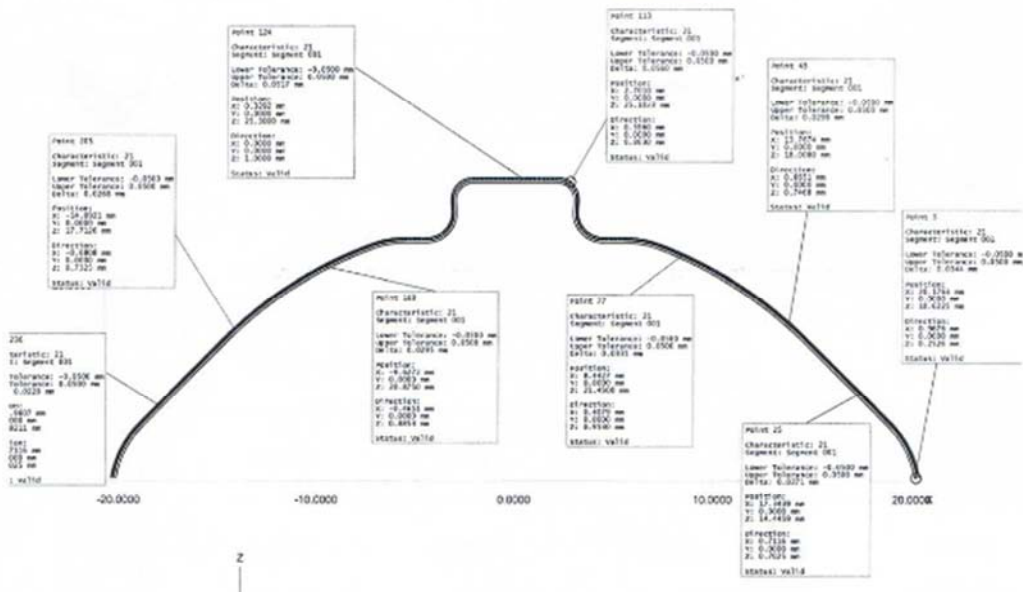
Figure 16. Measurements of the same liner: as received and after 4 years storage on the shelf.

The results of the two measurements of the same liner as is and stored on the shelf for 4 years were compared in Figure 16.

The results show that the liner is stable and did not change its dimensions within 4 years of storing on the shelf at room temperature.
